Home Inspection Report

3829 SE Harrison Street
Portland, 97214

Prepared for: Landon Bright

Prepared by: Browning Inspections LLC
9803 SE Hillcrest Rd
Happy Valley, 97086

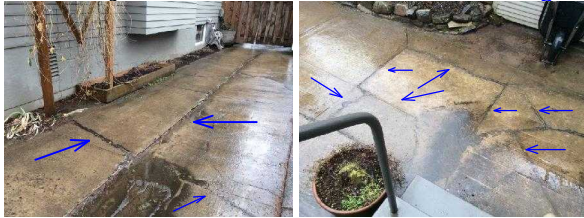
Driveway: Concrete - Differential cracking do to settling.

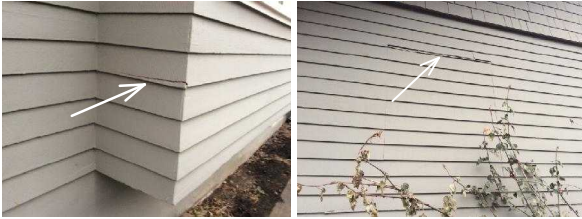
Type: Wood - Siding is generally in good condition with the exception of some small cracks. One on the west side and one on the east. Recommend filling and painting to prevent water intrusion.

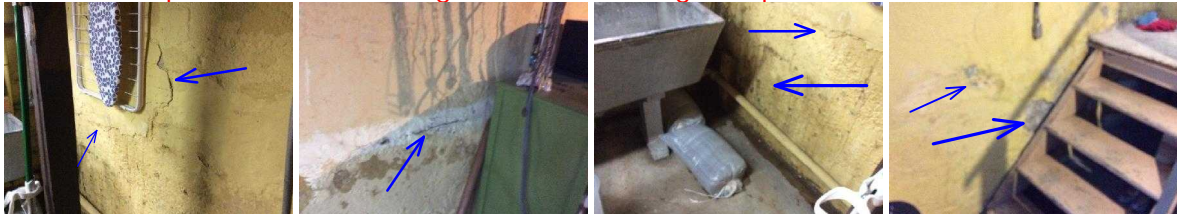
Half basement north end of house Basement
 Acceptable Ceiling: Exposed framing
 Defective Walls: Concrete - **NE corner of basement is wet. Differential horizontal cracks and spalling in foundation wall below grade. Moisture may be related to roof runoff. Recommend evaluation by a foundation specialist and a roofing contractor to diagnose problem and recommend a fix.**

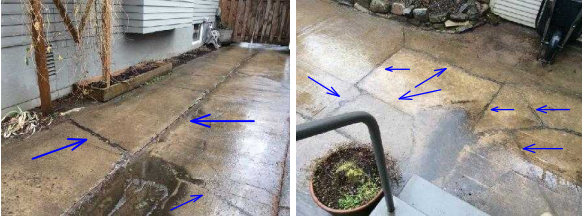
1. Driveway: Concrete - Differential cracking do to settling.

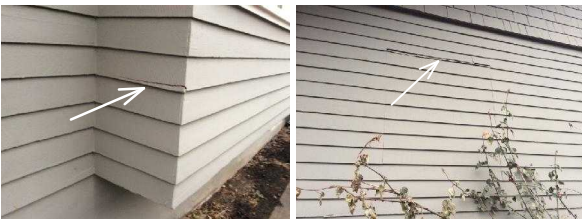
4. Whole House Exterior Surface Type: Wood - Siding is generally in good condition with the exception of some small cracks. One on the west side and one on the east. Recommend filling and painting to prevent water intrusion.

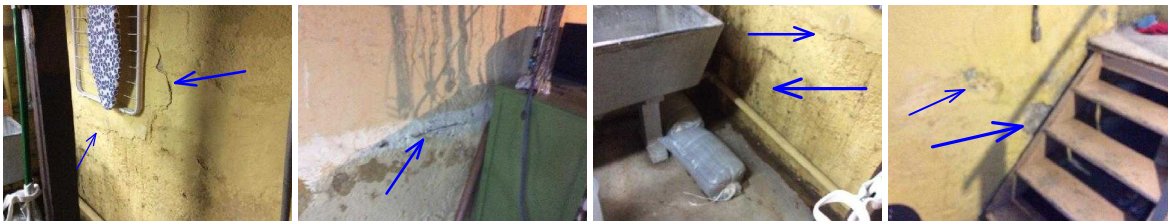
5. Half basement north end of house Basement Walls: Concrete - **NE corner of basement is wet. Differential horizontal cracks and spalling in foundation wall below grade. Moisture may be related to roof runoff. Recommend evaluation by a foundation specialist and a roofing contractor to diagnose problem and recommend a fix.**
